# ACCIDENT REPORT

## GJERTVASSTIND.

### Luster, Norway.

#### Report by the safety commission NKf.

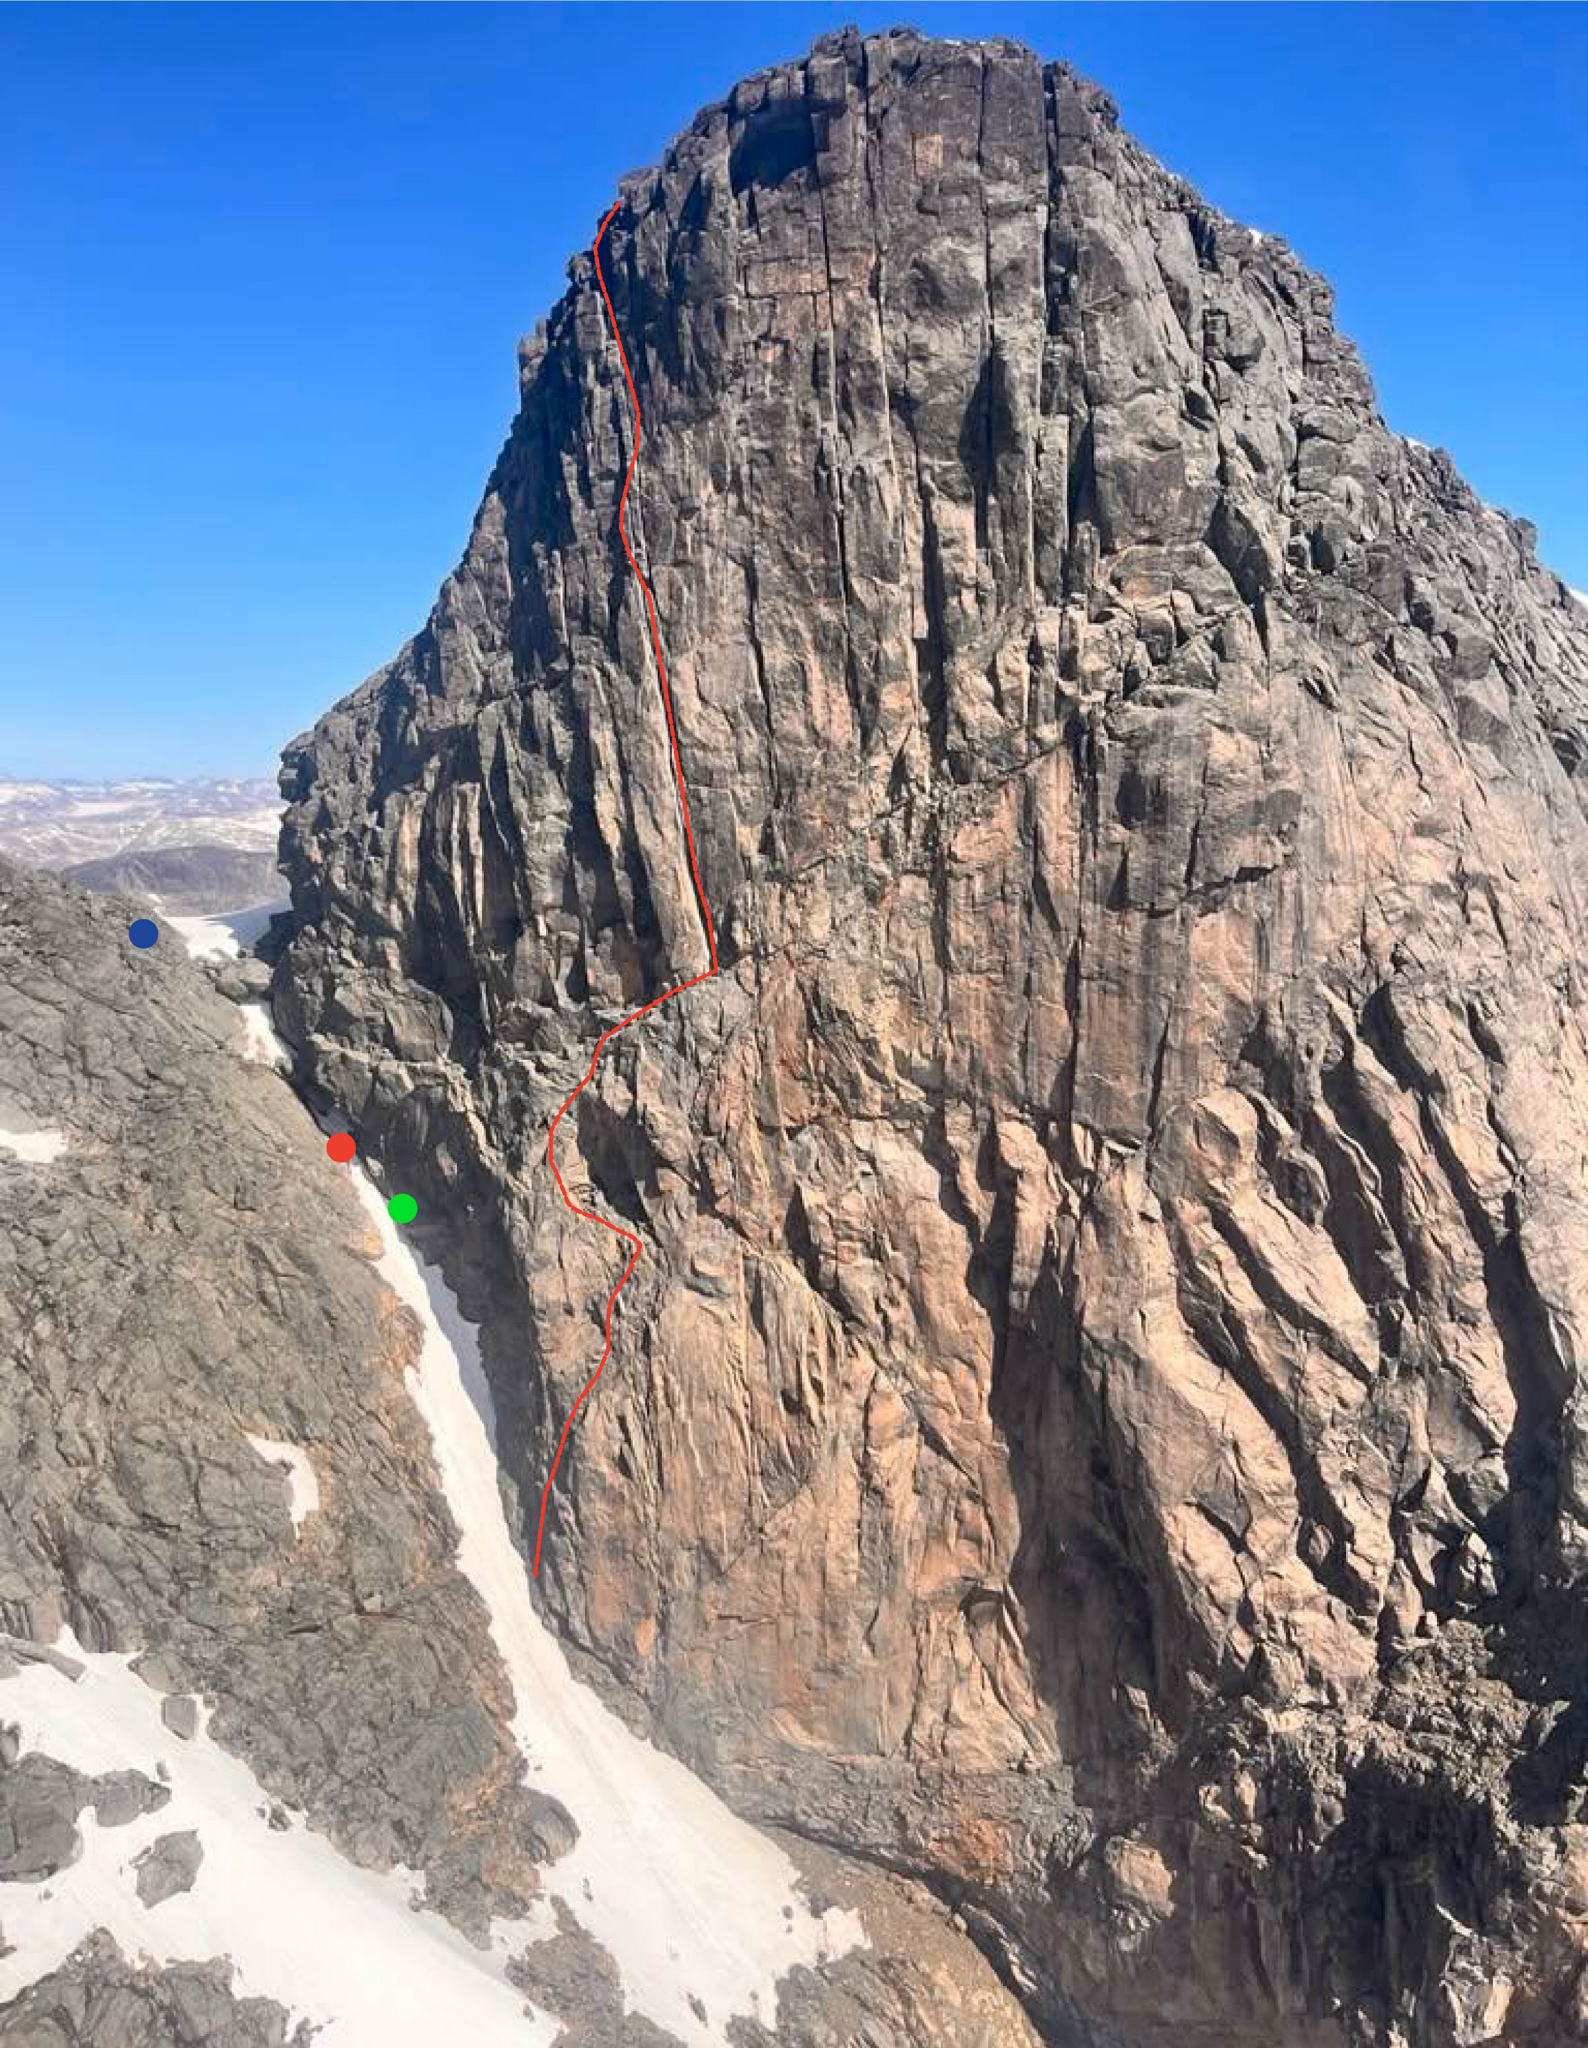
Based on the Norwegian climber's account, the climbers decided to rappel because the gully was approximately 60 degrees steep and the snow was icy and firm. They traversed a short section on the west side of the gully (left side in the photo) to reach the boulder they had chosen to use as their rappel anchor. Several climbing parties had rappelled from this boulder before, and they considered it safe. They placed a 7 mm static rope around the boulder and tied an overhand knot on a bight (Norwegian: slått overhåndsknute) on the static rope to create a master point/clipping loop (Norwegian: sentralpunkt) for the rappel. After completing the rappel, they would still need to downclimb a short section on snow to reach the start of the climb.

She reached a flat ledge below an overhang on the east side of the gully (right side in the photo), where she considered it safe to stand without being attached to the ropes or an anchor. She had about 5–10 meters of rope left when she disconnected her rappel device from the ropes.

*Aerial view of the South Face of Gjertvasstind. The climbing route follows the red line. The three circles shows the approximate locations of: Blue: Rappel anchor. Green: Norwegian climber after she finished the rappel. Red: Location of the US climber when the accident happened.*

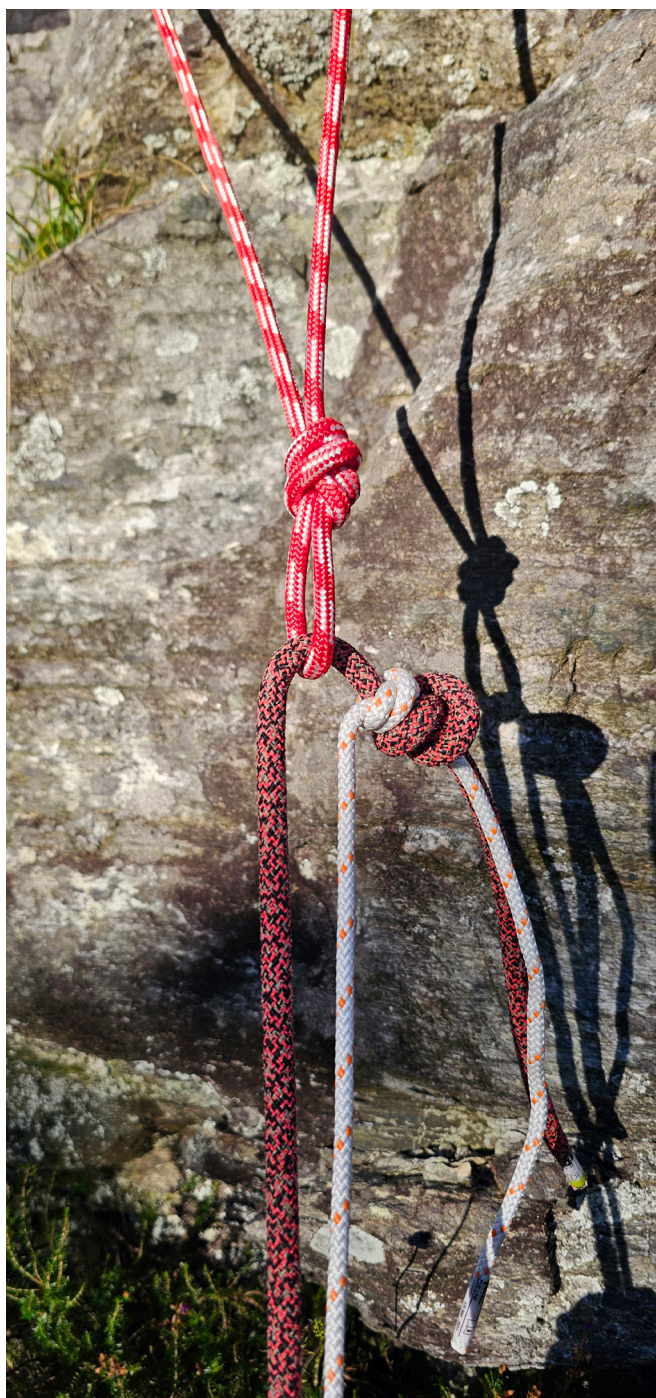
### **Illustrative photo**

The climbers threaded the single rope through the master point and used a flat double fisherman's knot (Norwegian: stående dobbel fiskeknute) to join the single rope to the tag line on the other side of the master point. They chose not to tie stopper knots at the ends of the ropes because they were concerned that the ropes could get stuck when thrown down. Since they were rappelling on a low angle rather than on a vertical wall, they felt confident in doing so. They did not establish any mechanism to prevent the stopper knot from moving through the master point (other than possibly the small size of the master point).

failed when the US woman was rappelling. The findings are compatible with the hypothesis that the joining knot has somehow made it through the master point loop and started migrating as described in A above. Given this scenario and that no stopper knots were used, the climber would eventually rappel off the tag line that has become shorter due to knot migration and start falling.

*The photo shows how the tag line was joined to the single rope by a flat double fisherman's knot and threaded through the master point before the climbers started rappelling. Note that this is not the actual anchor used, and the size of the master point loop used may differ.*
