# ACCIDENT REPORT

## LIPTON, RJUKAN

### February 22. 2015

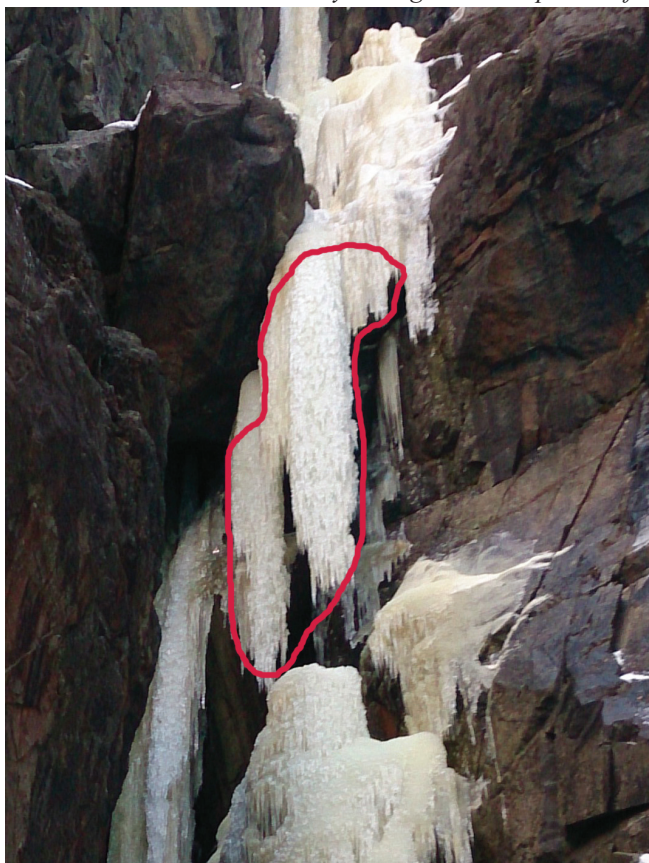
*Lipton before and after the accident. In addition to showing the amount of ice that fell down, one also can get an impression of how much ice that thawed away during the warm period of three days.*

*Lipton one week before the accident. The ice that collapsed is inside the red border.*

This accident was undoubtedly initiated by the large chunk of ice that fell down. It is interesting to look at the temperature history of Rjukan the previous week in order to understand how this could happen.

Warm temperatures of around 6-7 degrees for the three days prior to the weekend will have induced weakness in the hanging ice that was under high levels of tension due to having no base of support. One cannot say for certain that the ice fell down because it was climbed upon. Sometimes the ice comes down by itself as well due to the pull of gravity.

The accident serves as a sad reminder that ice can be unstable, and that we always need to evaluate the conditions carefully before starting a climb.

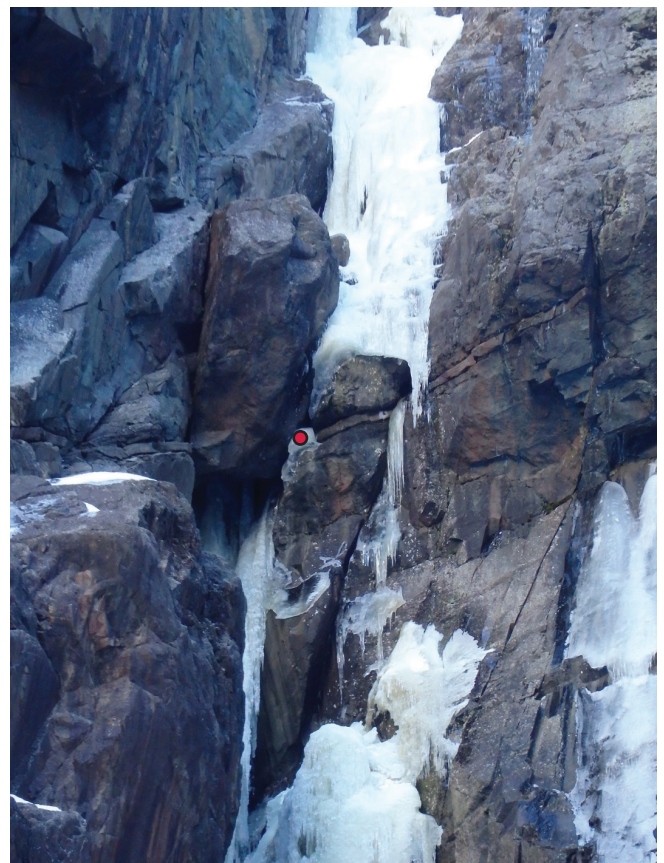
*Lipton just after the accident. The red dot indicates the placement of the ice screw that stopped the fall. Photo by Robert Goodman*

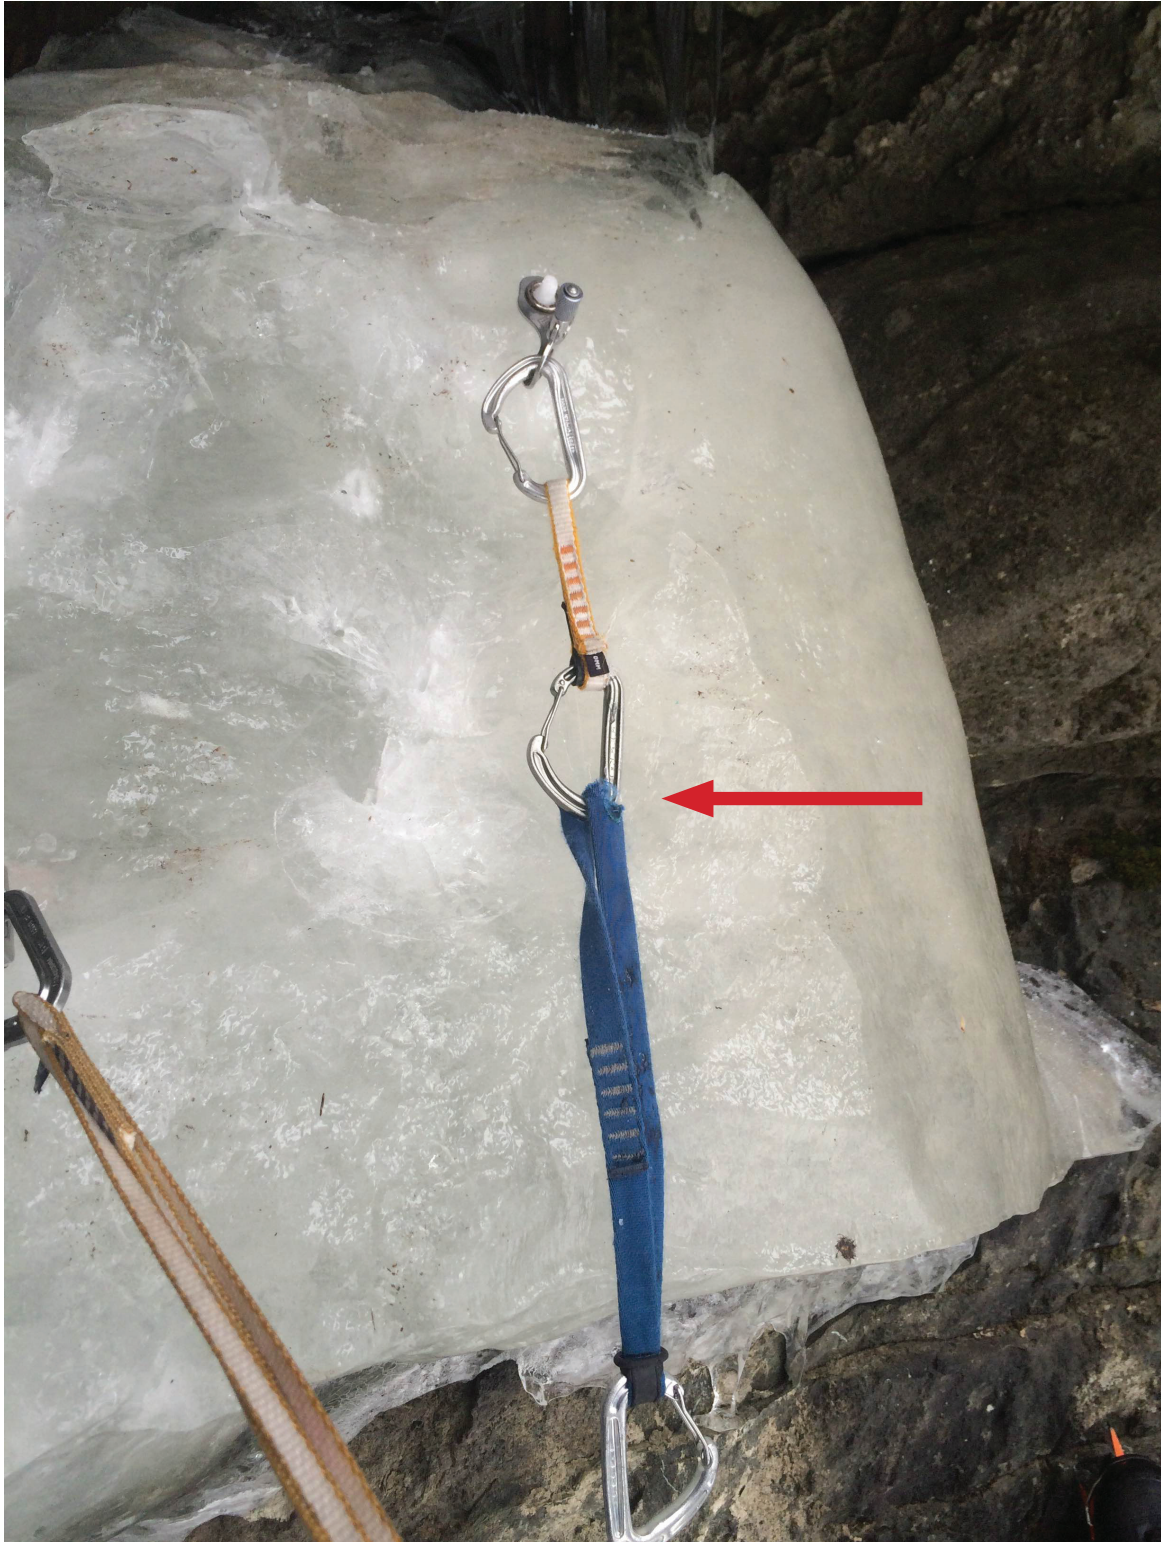
They found the ice screw that stopped the fall still in place where the climber originally put it. A dyneema quickdraw (orange) was clipped into the screw, and this was extended by an open nylon sling (blue). This is usually done here to prevent the rope from jamming and getting stuck in the rock. While the screw and the carabiners are undamaged, the nylon sling shows extensive damage. Upon closer examination, it turns out that the nylon sling has almost ripped apart in the upper end. Only 25% of the weaving is left where the sling was damaged.

*The screw that arrested the fall. Untouched after the accident. Note the ripping in the upper end of the blue sling.  
Photo by Martin Skaar Olsund*

While there was no clear conclusion in the initial report of whether the falling ice was attached to the climber's last ice screw or not, the new information gives overwhelming evidence in support of a conclusion that the screw was indeed attached to the large chunk of ice that fell down. There is no likely scenario in which the sling could have sustained this kind of damage from friction against rock or falling ice given its placement. The only likely explanation left is that the forces in play has been enormous, and that the sling has been exposed to forces of approximately 22 kN (weight of 2200 kg). The massive amount of ice that fell down must have exerted a strong pull in the rope in order to create this kind of force. The equipment is not built to handle the forces of a mass of several hundred kilos in a lead fall.

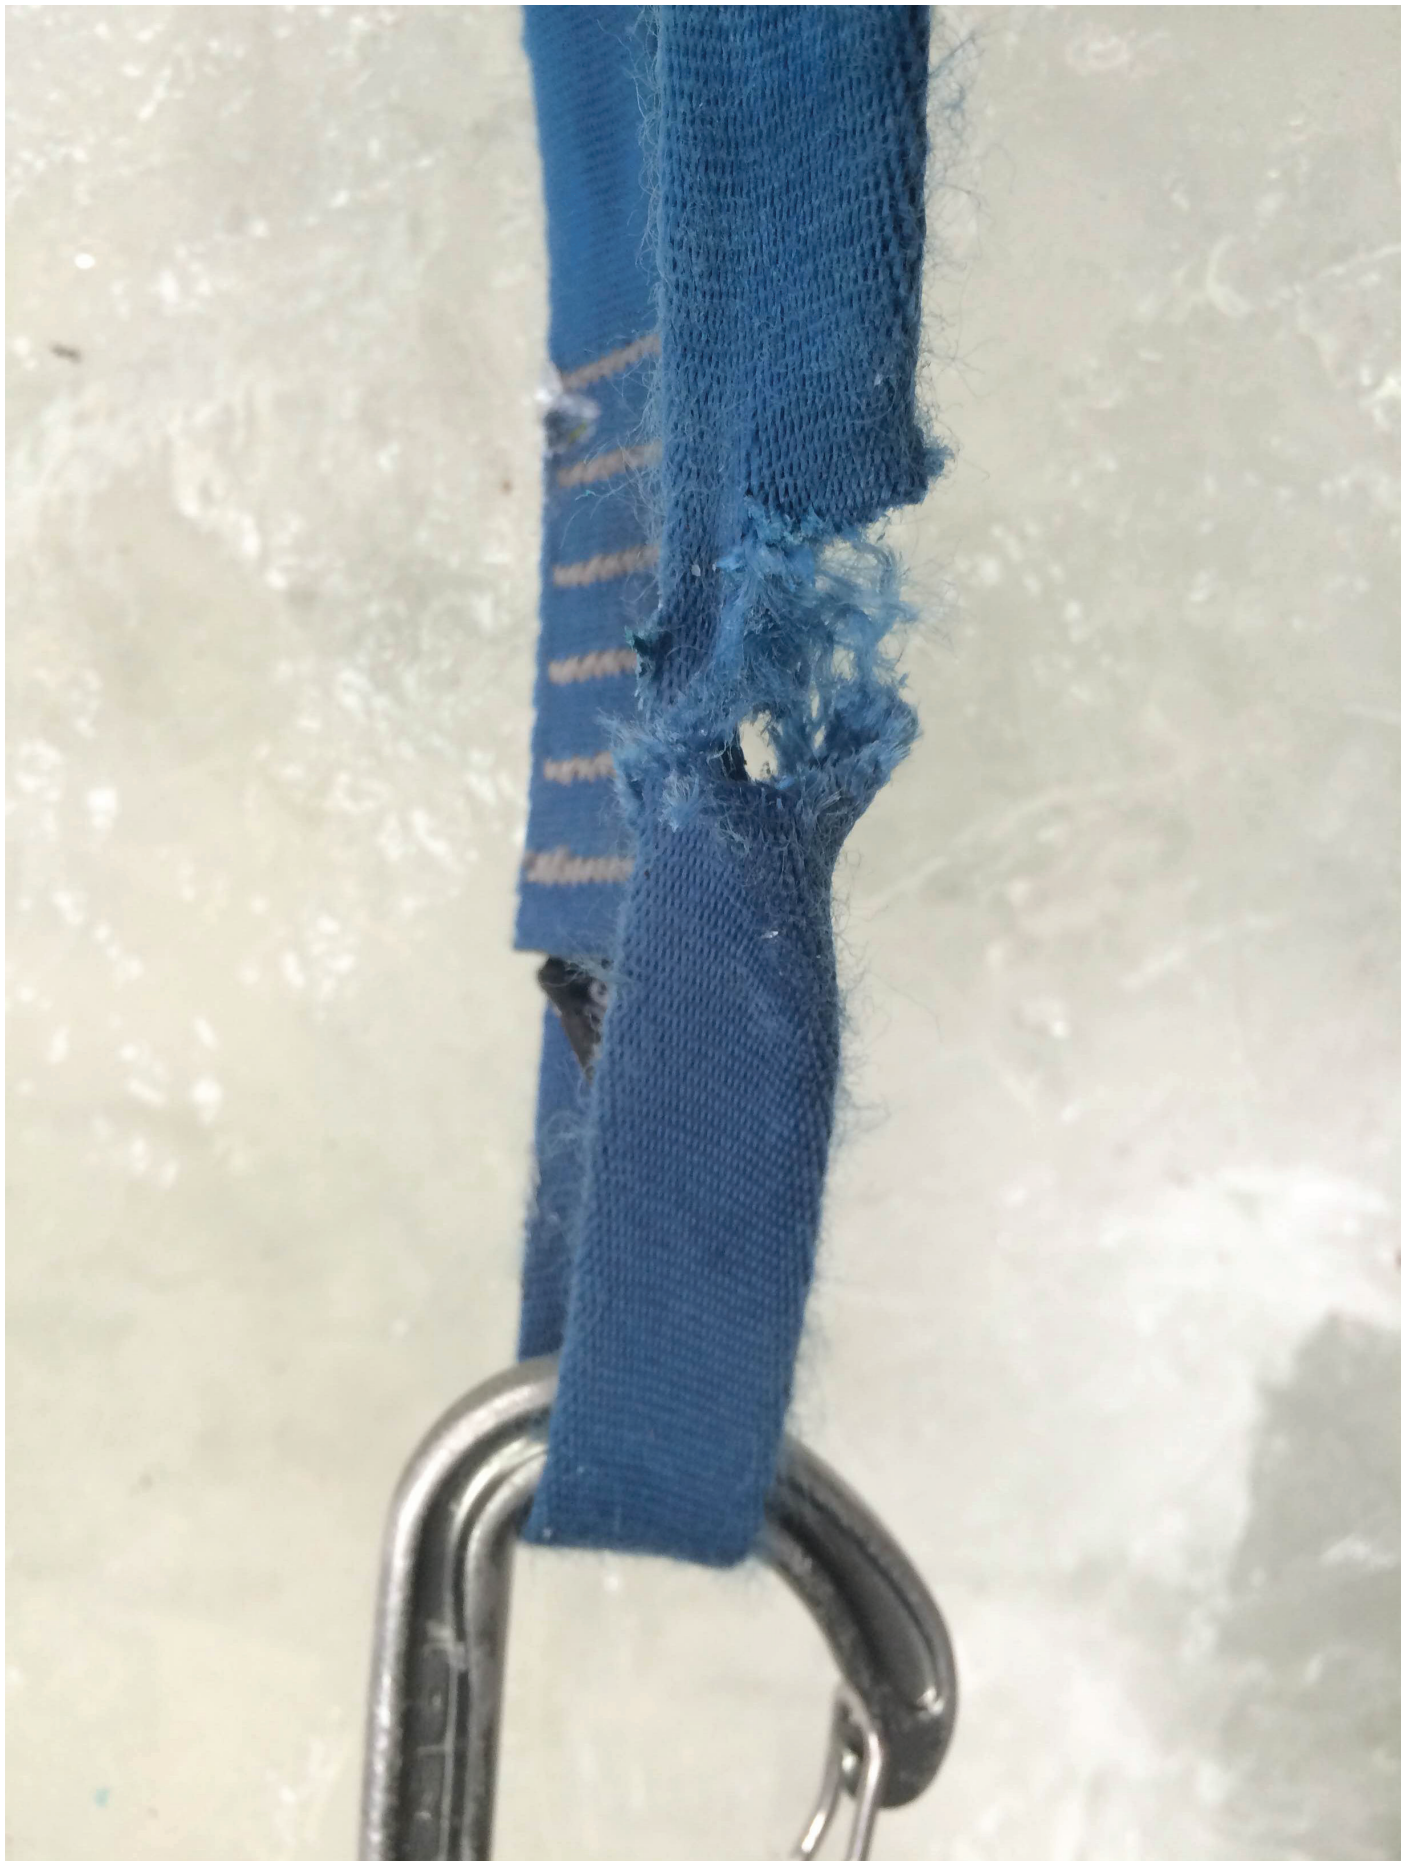
*Enormous forces has been at work during the fall and almost completely ripped the nylon sling.  
Photo by Martin Skaar Oslund*

Given the scenario with a chunk of falling ice weighing several hundred kilos attached to the rope via an ice screw and a quickdraw, the climber will stand no chance. The climber will be pulled off the ice with enormous forces. Since he is attached to the end of the rope which pulls him down in addition to gravity, his acceleration will be larger than that of the falling ice. He will come underneath the ice and be smashed by it as the ice hits the climber's end of the rope.
