# ACCIDENT REPORT

## GJERTVASSTIND.

### Luster, Norway.

#### Report by the safety commission NKf.

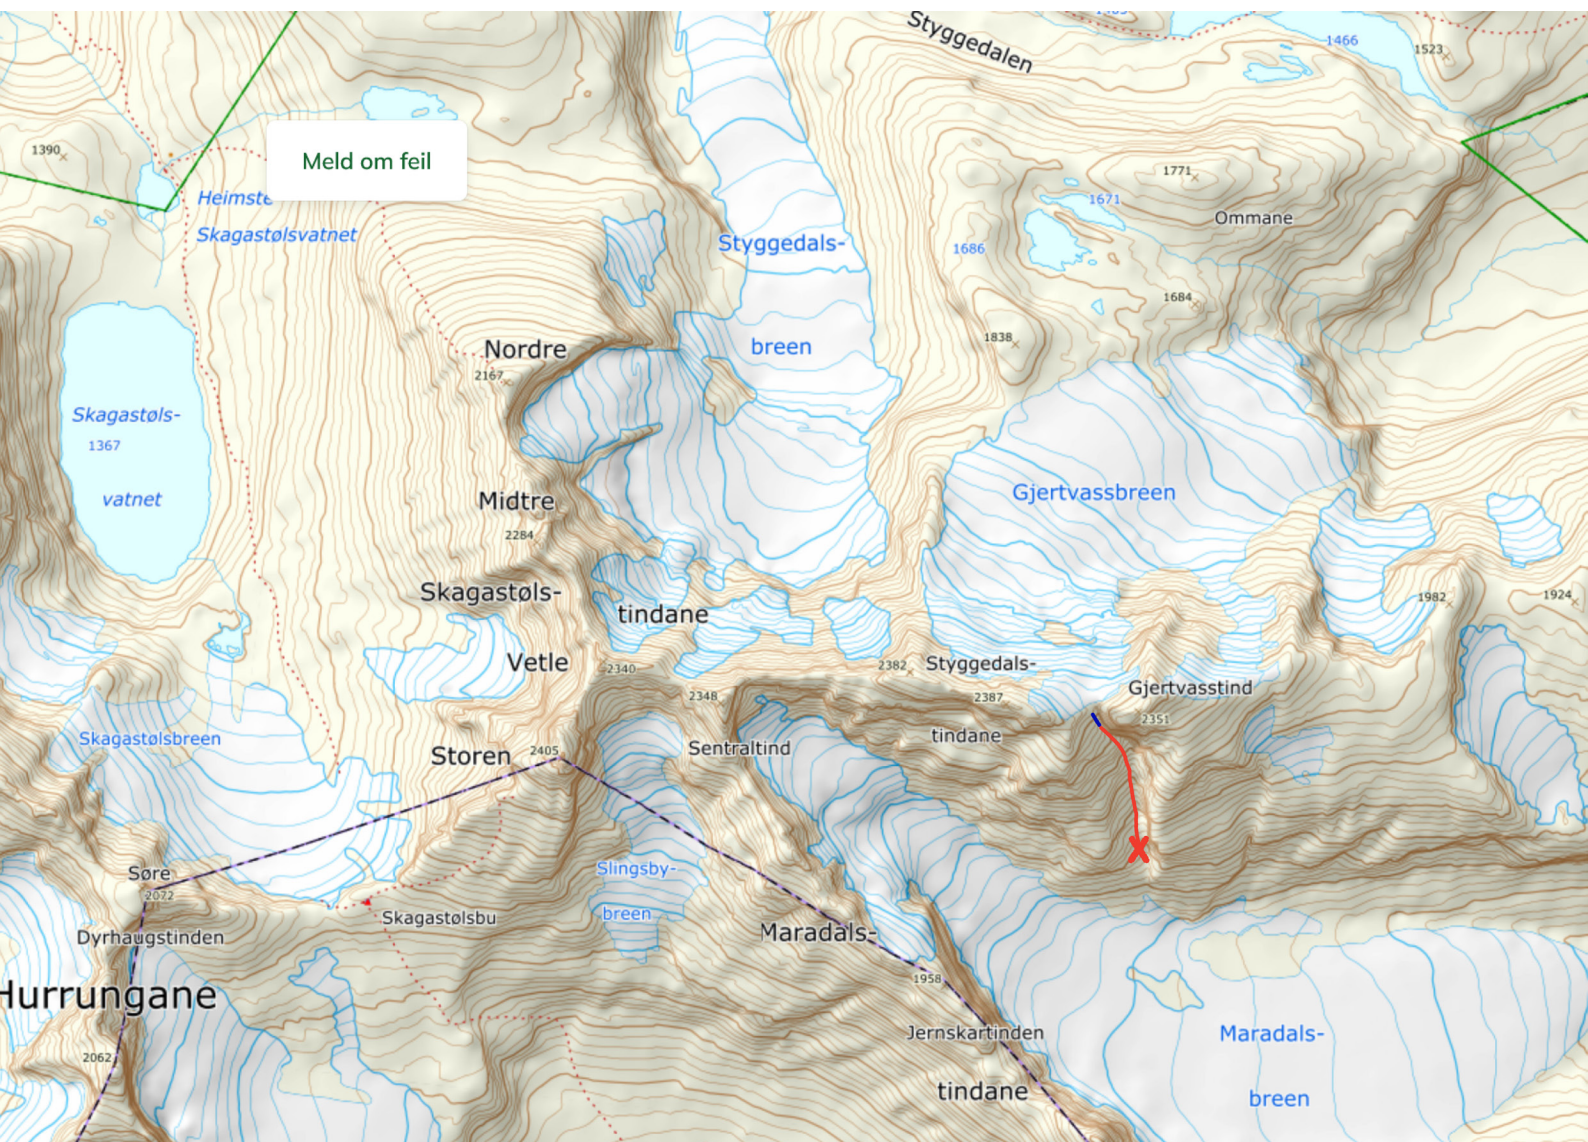
*This map excerpt depicts the alpine terrain in which the accident took place, focusing on the Styggedal Ridge, of which Gjertvasstind forms a part. The blue line indicates the planned rappel route, while the red line shows the fall trajectory. X marks the point of discovery.*
